PAVEMENT MANAGEMENT REPORT

COUNTY OF RIVERSIDE TRANSPORTATION DEPARTMENT

PAVEMENT MANAGEMENT REPORT 2012

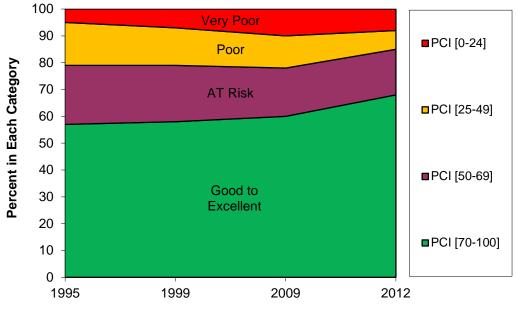
Figure 1. Pavement Condition Trendline (Countywide)

The percentage of mileage categorized by condition rating (good to excellent, at risk, poor, and very poor) over the last 17 years is summarized in Table 3. This table is also presented graphically showing the pavement condition trend in Figure 1 below.

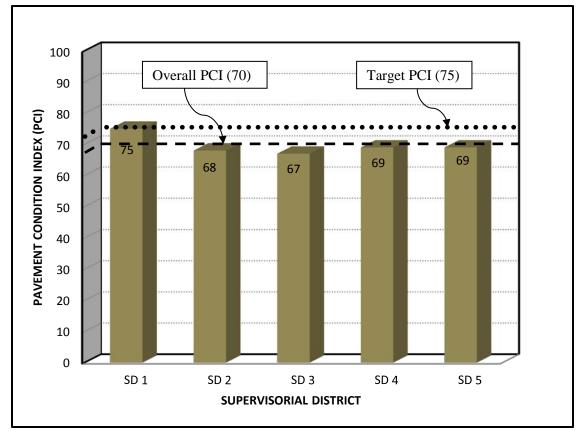
Figure 2. Pavement Condition Index by Supervisorial District

The Target PCI of 75, as shown in Figure 2, is based on a set goal that all pavements throughout the County road network system need to reach a condition where Best Management Practices (BMP) can occur. This means that only the most cost-effective pavement preservation treatments are needed, such as, chip seal, slurry seal, and cape seal. Reaching and maintaining the target PCI offers other benefits (other than cost) such as reduced impact to the public in terms of:

As noted on the chart in Figure 2, the overall PCI of 70 is considered "Good" by definition of PCI shown in Figure 7 (page 1), "Relationship between PCI and Condition," of this report. From the generalized pavement deterioration curve shown in Figure 9 (page 5), "Pavement Deterioration Curve," of this report, a PCI below 70 signifies a pavement at risk. The roadway network's life and deterioration accelerates rather rapidly at a PCI between 50 and 69 and if repairs are delayed by just a few years, preventative maintenance could increase the cost of the treatment significantly, as much as ten times.

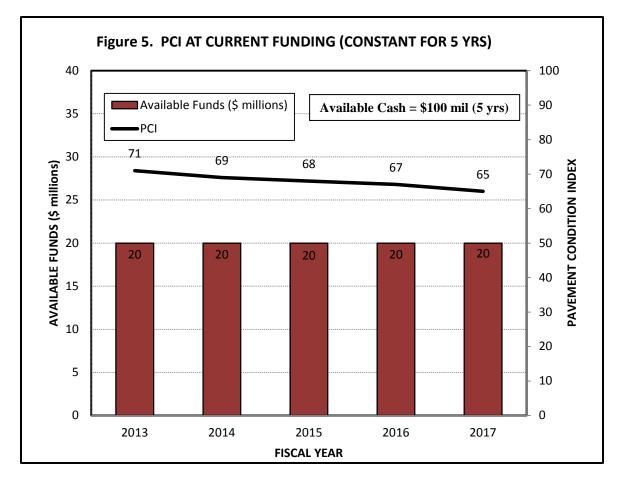
As illustrated by the funding scenario in Figure 5, maintaining the current funding of \$20 million annually for the next 5 years will have an impact on the PCI of the road network. Initially for the first year, the PCI will reach 71 (from 70 of FY 2012) starting in 2013 then gradually declining to 65 over a 5-year period.

Given the two funding scenarios illustrated in Figure 5 and Figure 6 for the needs and available cash, the funding shortfall can be calculated. For each scenario, the total cost or available cash is simply the sum of each cost or available cash per year for 5 years. As depicted in Table 4, the shortfall is \$196 million. Clearly, the available funding is inadequate in meeting the BMP goal within the period analyzed. Based on the results of this analysis, approximately \$196 million of additional funding is needed to bring the pavement condition of the county roads to a PCI of 75.

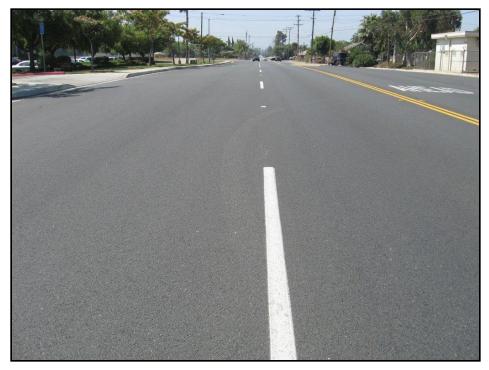
Figure 8A. PCI=98 (Excellent Condition)

In the MTC StreetSaver software, the pavement condition assessment is based on collecting data to determine the type, amount, and severity of surface distress for each segment of pavement being managed. The distress data is used to calculate a Pavement Condition Index (PCI), which is based on a visual survey of the pavement and a numerical index between 0 and 100, with 0 being defined as failed roadway and 100 representing an excellent pavement (newly paved). Figure 7 shows the relationship between the PCI and pavement condition. Photos showing examples of pavement in excellent through very poor conditions are shown in Figure 8A through 8F.

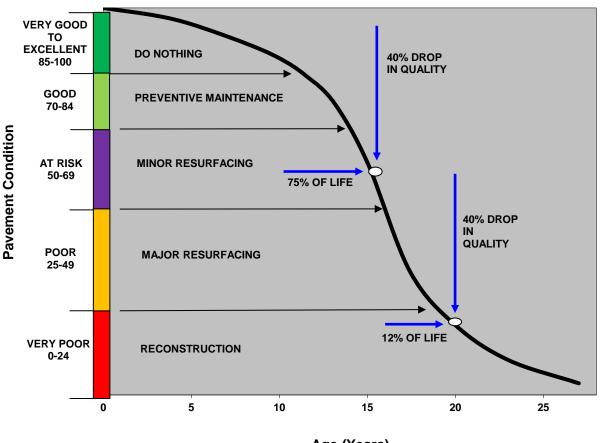
Figure 9. Pavement Deterioration Curve

A critical concept in overall pavement life is the timing of maintenance and rehabilitation (resurfacing or reconstruction) actions being undertaken before the pavement falls beyond the optimum rehabilitation point. Figure 9 demonstrates this concept. Notice that for the first 75 percent of pavement life, the pavement condition drops by about 40 percent. However, if left untreated, it only takes another 12 percent of pavement life for the pavement condition to drop another 40 percent. Additionally, in order to restore pavement condition to a predetermined or an acceptable minimum level (i.e., PCI of 70 or higher), it will cost 4 to 5 times as much if the pavement is allowed to deteriorate for 2 to 3 years beyond the optimum rehabilitation point (PCI of 50), as illustrated in Figure 9.

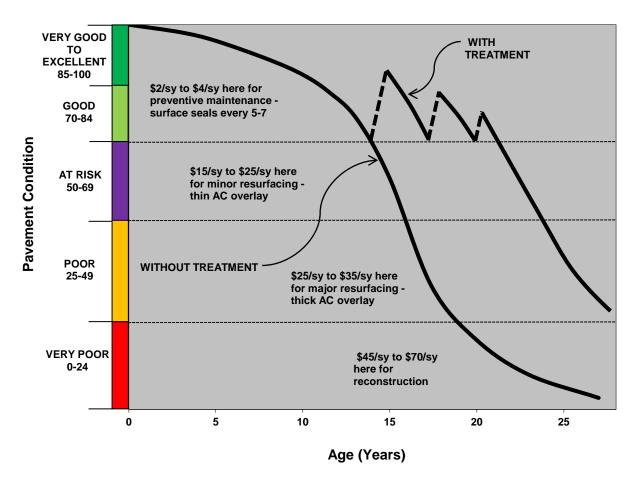
Figure 10. Pavement Deterioration Curve With and Without Treatment

An effective pavement preservation program will treat pavements while they are still in good condition and prior to the need for major reconstruction work. By applying a cost-effective treatment at the right time, the pavement is restored almost to its original condition. Figure 10 illustrates the concept of pavement preservation as it relates to enhancing pavement performance, extending pavement life, and ensuring taxpayer dollars are utilized wisely while providing improved safety and mobility to the public.

As depicted in Figure 4, the cumulative effect of systematic, successive preservation treatments is the postponement of costly resurfacing and reconstruction. During the life of a pavement, the cumulative discount value of the series of pavement preservation treatments is substantially less than the discounted value of the more extensive, higher cost of reconstruction and generally more economical than the cost of major resurfacing.

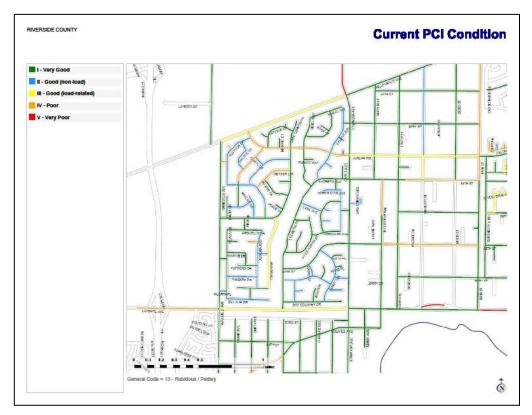
Figure 13. PMP result on GIS map.

The integration of the PMP with Geographic Information Systems (GIS) has provided the County a snapshot of the roadway network to better organize the data collected and facilitates in the decision-making in selecting roads to be included for treatment/repair in the upcoming fiscal year. An example of the PMP/GIS integration is shown in Figure 13.

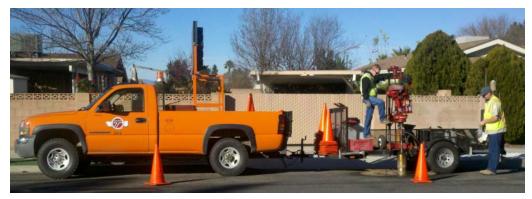
Figure 14. County's Coring Rig

The County invests millions of dollars each year in pavement maintenance activities. Records of performance of the pavement maintenance treatments placed during these activities are crucial in order to determine which treatment alternative is the best option to use. With advancements in data collection practices and equipment, the County invested in a Ground Penetrating Radar (GPR) and a Falling Weight Deflectometer (FWD) in addition to its already established data collection methodology of using coring and visual inspection survey. Figure 14 and Figure 15 depict the road data collection equipment.

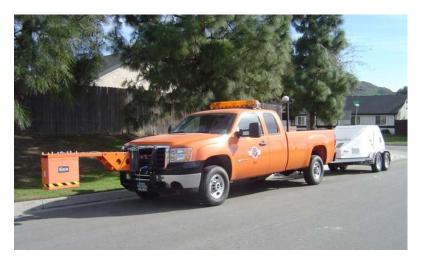
Figure 15. FWD and GPR Data Collection Equipment

The GPR is used to measure pavement layer thickness and detect groundwater or voids beneath the pavement. The FWD characterizes pavement structural condition. Data collected from this state of the art equipment provide new information that can be used to improve pavement management recommendations as well as support the County's pavement rehabilitation and design activities.

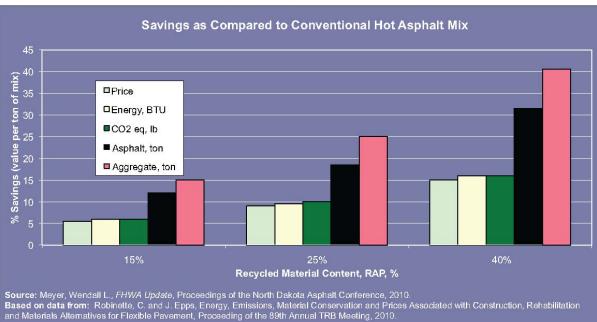
From the chart illustrated in Figure 18, some environmental benefits and cost savings of using at least 15 percent RAP in conventional HMA will yield a reduction in asphalt by about 12%, a decrease of virgin aggregate by about 15%, and a reduction of greenhouse gas emissions at a rate of 5 pounds per ton of RAP used in the hot mix asphalt.

Price corresponds to materials, construction, rehabilitation, and maintenance costs based on Life Cycle Cost Analysis (LCCA) with environmental impact assessment. Energy (BTU) represents the requirements for construction materials processing and construction material production. CO2 eq (lb) is a measure of greenhouse emissions and it includes the production of raw materials, transportation, production and laydown of materials. Asphalt and Aggregate in tons are considered the natural resources. [Sources: Transportation Research Board and Federal Highway Administration (FHWA)].
