**COUNTY OF RIVERSIDE
TRANSPORTATION DEPARTMENT**

PAVEMENT MANAGEMENT REPORT

2014

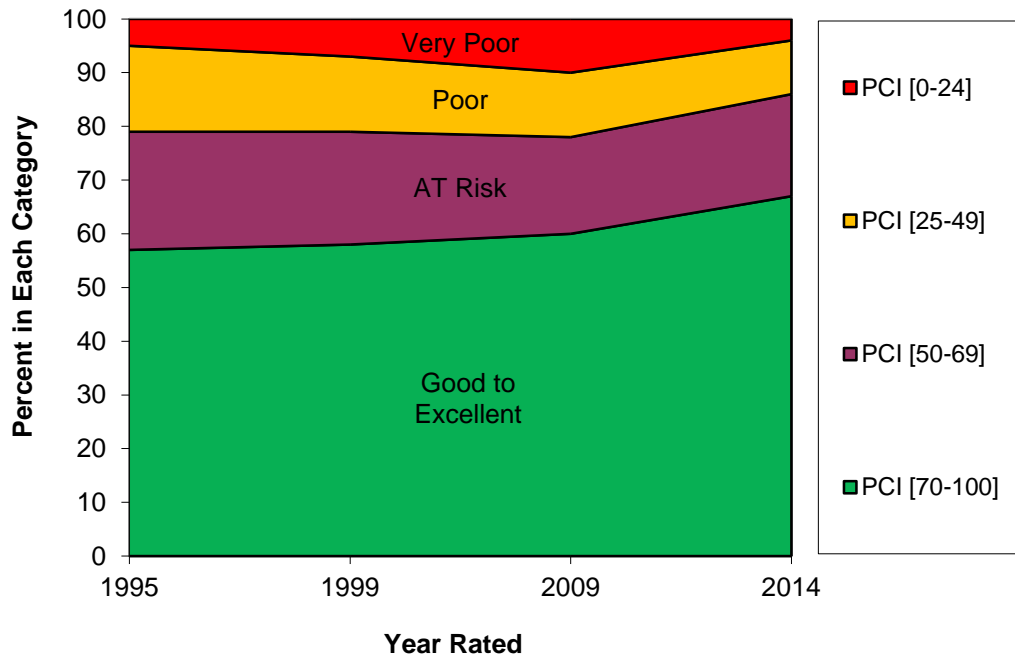
Figure 1. Pavement Condition Trendline (Countywide)

The percentage of mileage categorized by condition rating (good to excellent, at risk, poor, and very poor) over the last 18 years is summarized in Table 3. This table is also presented graphically showing the pavement condition trend in Figure 1 below.

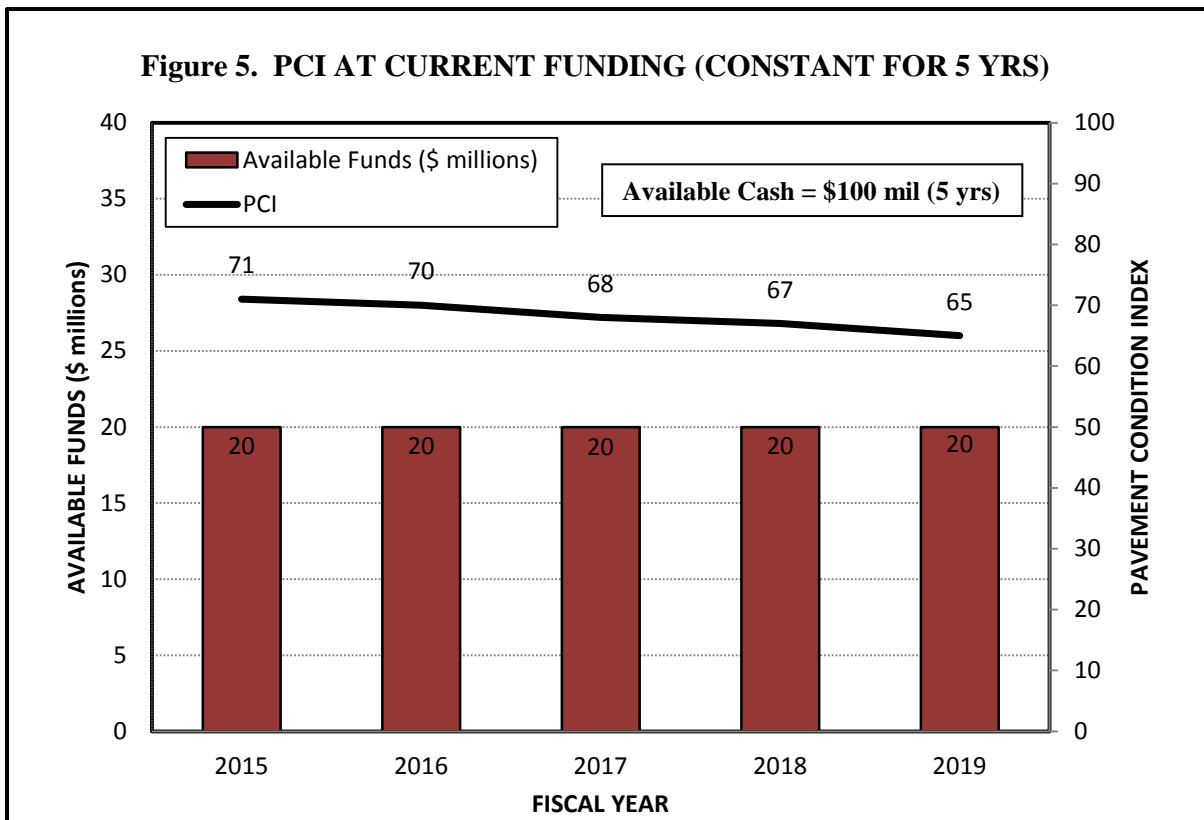
As illustrated by the funding scenario in Figure 5, maintaining the current funding of \$20 million annually for the next 5 years will have an impact on the PCI of the road network. Initially for the first year, the PCI will be 71 starting in 2015 then gradually declining to 65 over a 5-year period.

Given the two funding scenarios illustrated in Figure 5 and Figure 6 for the needs and available cash, the funding shortfall can be calculated. For each scenario, the total cost or available cash is simply the sum of each cost or available cash per year for 5 years. As depicted in Table 4, the shortfall is \$217 million. Clearly, the available funding is inadequate in meeting the BMP goal within the period analyzed. Based on the results of this analysis, approximately \$217 million of additional funding is needed to bring the pavement condition of the county roads to an overall PCI of 75.

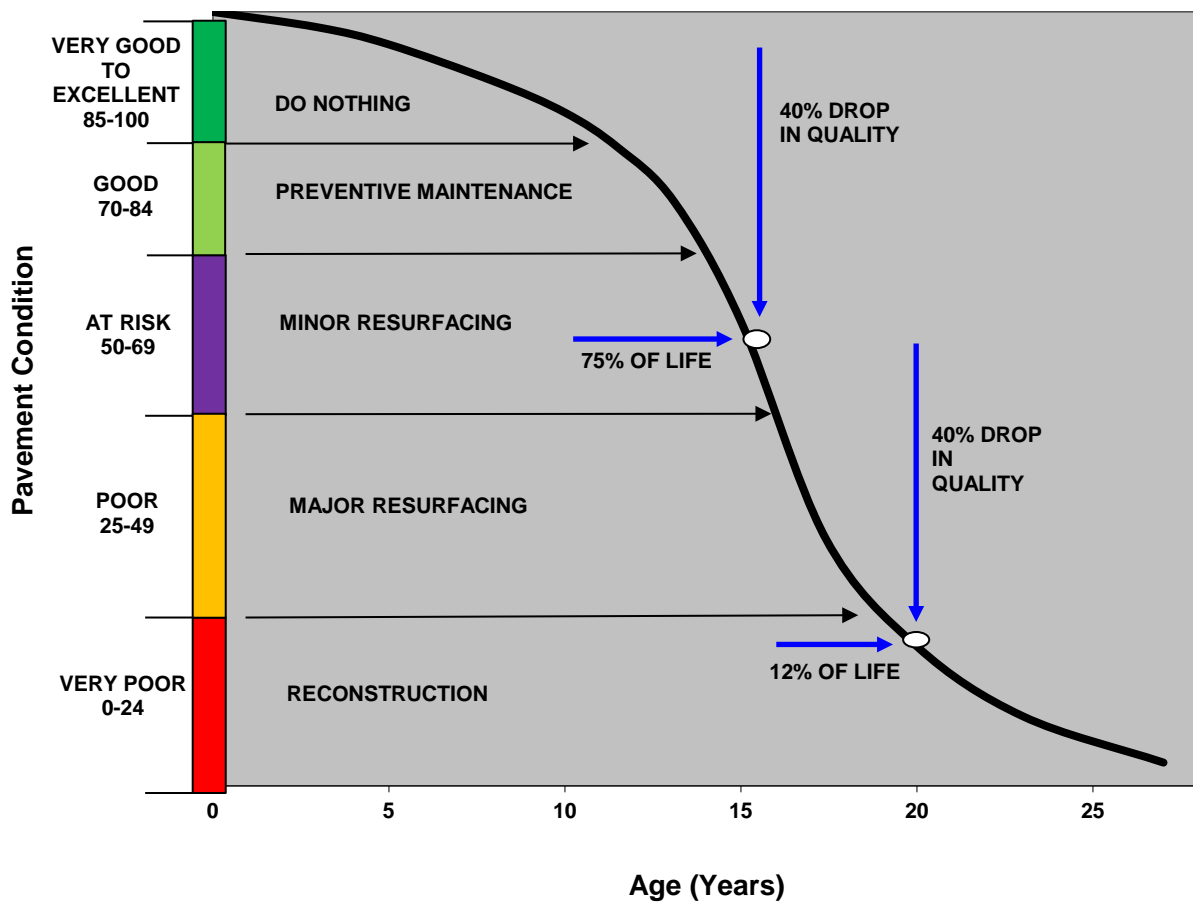
Figure 12. Pavement Deterioration Curve

A critical concept in overall pavement life is the timing of maintenance and rehabilitation (resurfacing or reconstruction) actions being undertaken before the pavement falls beyond the optimum rehabilitation point. Figure 12 demonstrates this concept. Notice that for the first 75 percent of pavement life, the pavement condition drops by about 40 percent. However, if left untreated, it only takes another 12 percent of pavement life for the pavement condition to drop another 40 percent. Additionally, in order to restore pavement condition to a predetermined or an acceptable minimum level (i.e., PCI of 70 or higher), it will cost 4 to 5 times as much if the pavement is allowed to deteriorate for 2 to 3 years beyond the optimum rehabilitation point (PCI of 50), as illustrated in Figure 12.

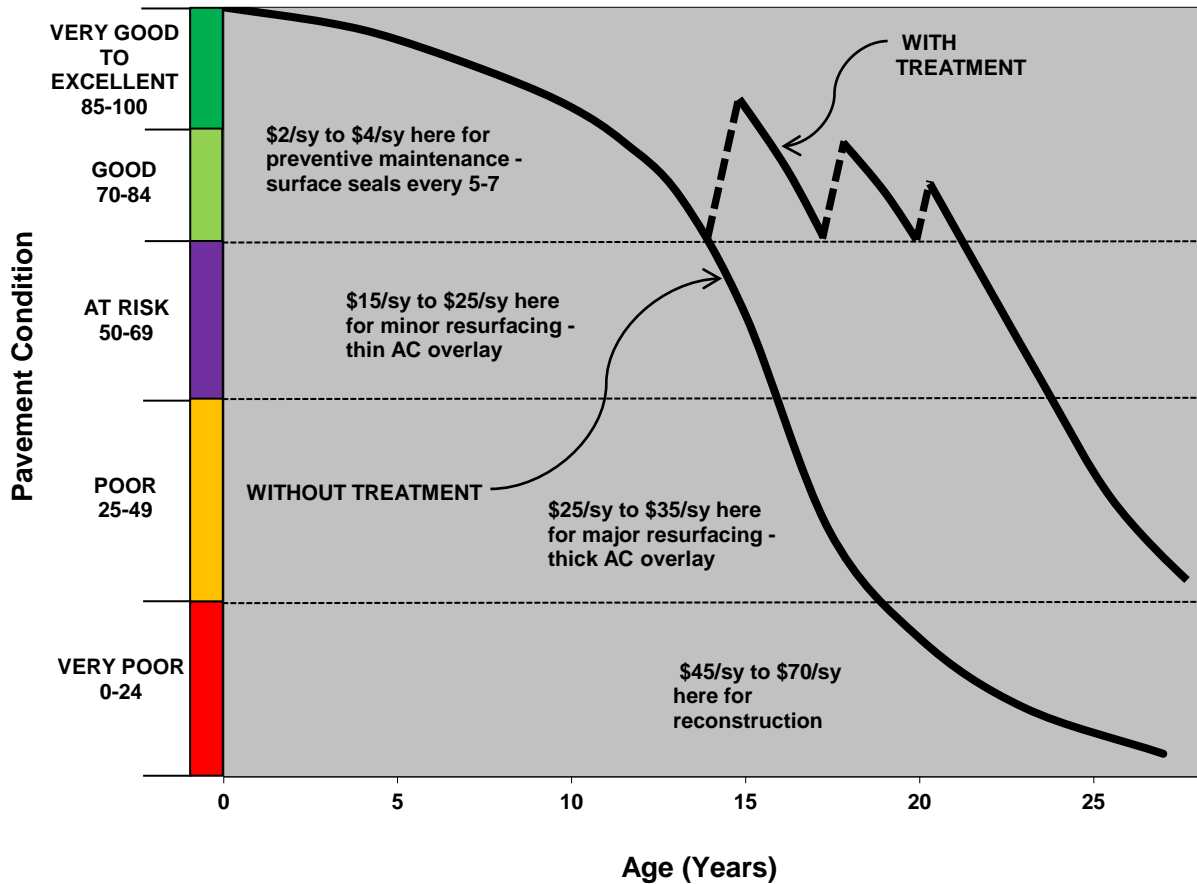
Figure 13. Pavement Deterioration Curve With and Without Treatment

As depicted in Figure 13, the cumulative effect of systematic, successive preservation treatments is the postponement of costly resurfacing and reconstruction. During the life of a pavement, the cumulative discount value of the series of pavement preservation treatments is substantially less than the discounted value of the more extensive, higher cost of reconstruction and generally more economical than the cost of major resurfacing.

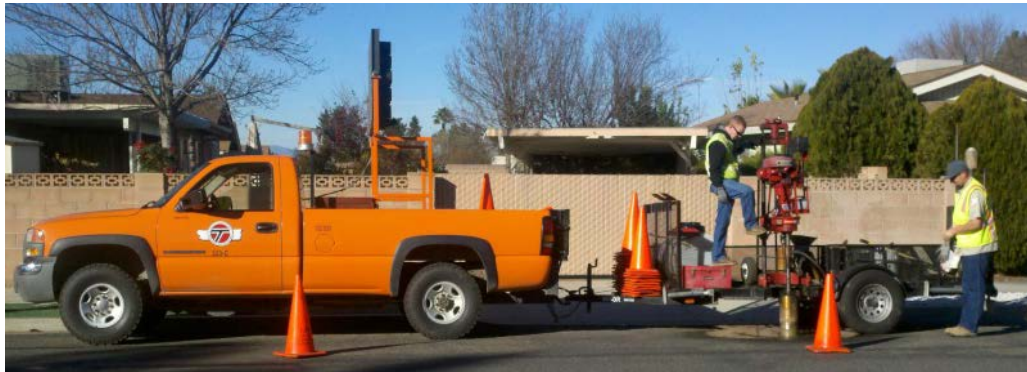
Figure 17. County's Coring Rig

The County invests millions of dollars each year in pavement maintenance activities. Records of performance of the pavement maintenance treatments placed during these activities are crucial in order to determine which treatment alternative is the best option to use. With advancements in data collection practices and equipment, the County invested in a Ground Penetrating Radar (GPR) and a Falling Weight Deflectometer (FWD) in addition to its already established data collection methodology of using coring and visual inspection survey. Figure 17 and Figure 18 depict the road data collection equipment.

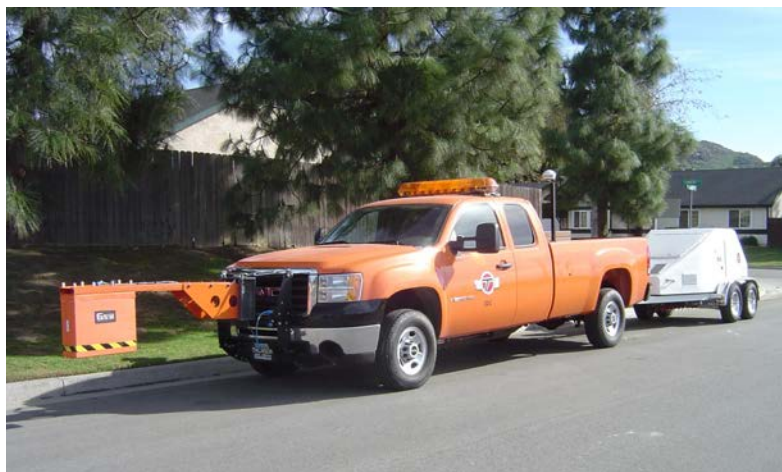
Figure 18. FWD and GPR Data Collection Equipment

The GPR is used to measure pavement layer thickness and detect groundwater or voids beneath the pavement. The FWD characterizes pavement structural condition. Data collected from this state of the art equipment provide new information that can be used to improve pavement management recommendations as well as support the County's pavement rehabilitation and design activities.

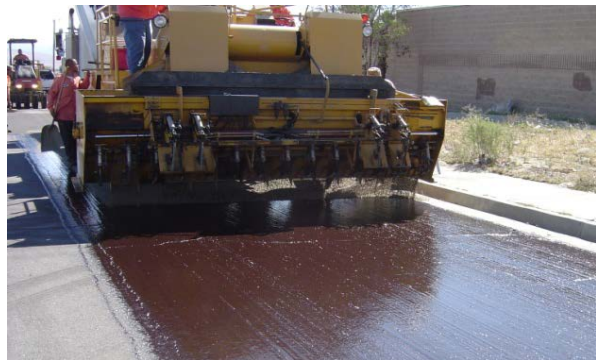
Figure 19. Spreading of chip over emulsion.

A chip seal is a surface treatment applied to pavement with minimal surface distress to provide a new wearing surface, extend pavement life, and delay major rehabilitation or reconstruction. It is a process in which an asphalt emulsion is sprayed on the pavement then immediately covered by aggregate. Figure 19 illustrates the spreading of aggregate over the sprayed emulsion. When the asphalt emulsion is applied to the road surface in conjunction with a mechanized scrub broom (that forces the emulsion into the cracks), this process is called "scrub seal."

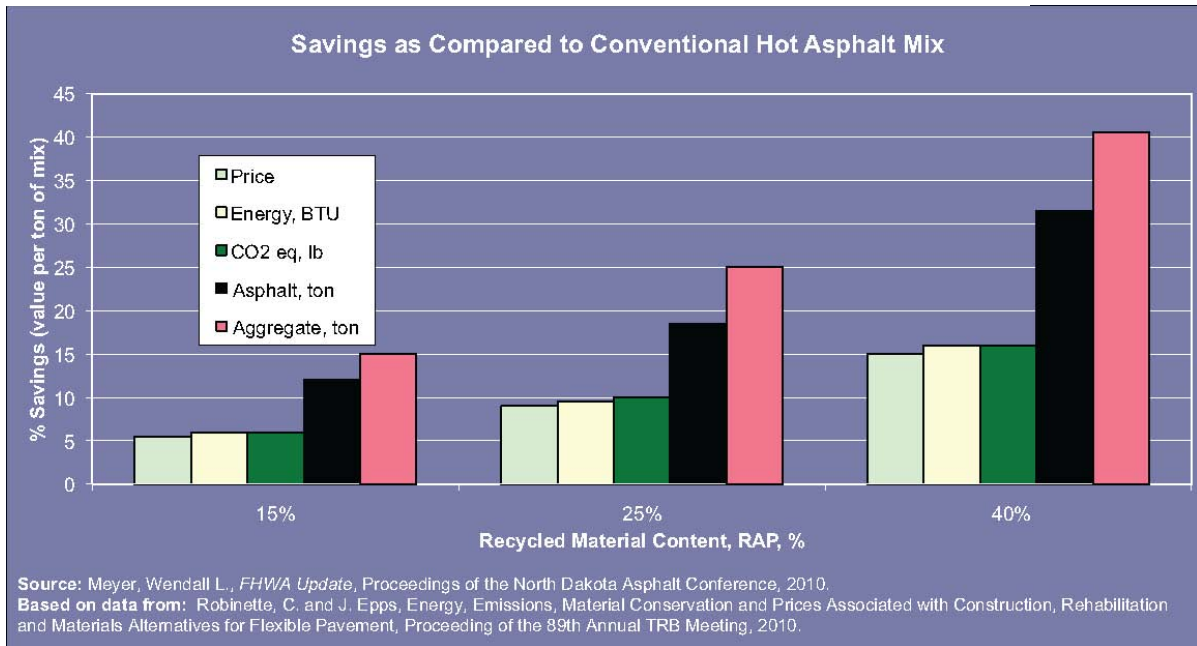
Figure 21. Benefits and Cost Savings of using RAP.

From the chart illustrated in Figure 21, some environmental benefits and cost savings of using at least 15 percent RAP in conventional HMA will yield a reduction in asphalt by about 12%, a decrease of virgin aggregate by about 15%, and a reduction of greenhouse gas emissions at a rate of 5 pounds per ton of RAP used in the hot mix asphalt.

Price corresponds to materials, construction, rehabilitation, and maintenance costs based on Life Cycle Cost Analysis (LCCA) with environmental impact assessment. Energy (BTU) represents the requirements for construction materials processing and construction material production. CO2 eq (lb) is a measure of greenhouse emissions and it includes the production of raw materials, transportation, production and laydown of materials. Asphalt and Aggregate in tons are considered the natural resources. [Sources: Transportation Research Board and Federal Highway Administration (FHWA)].
