COUNTY OF RIVERSIDE
TRANSPORTATION DEPARTMENT

PAVEMENT MANAGEMENT REPORT
2021/22

Riverside County Transportation Dept
2021/22 Pavement Management Report

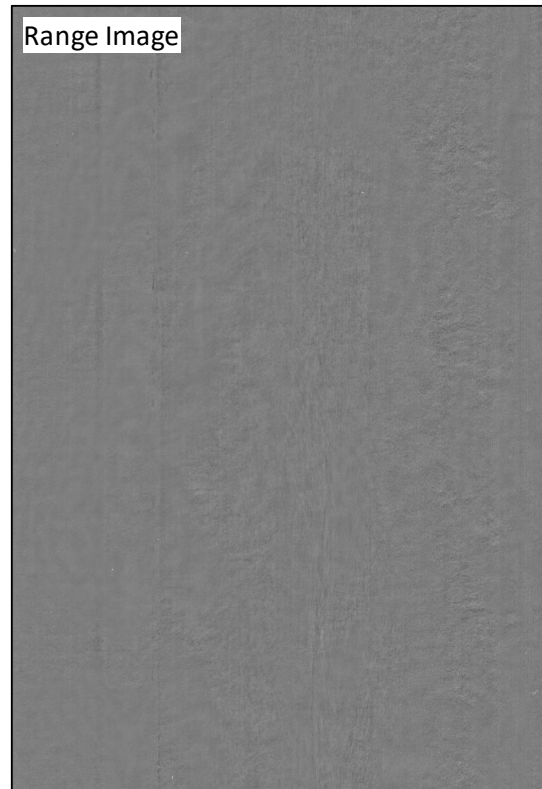
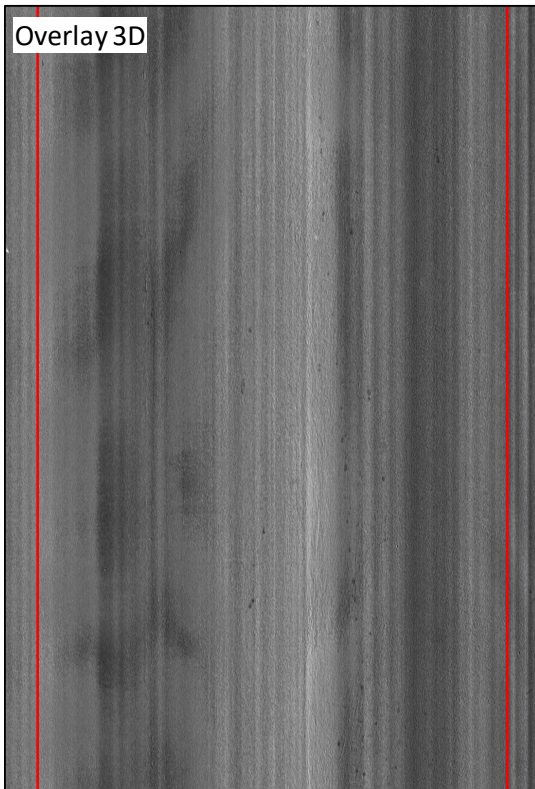
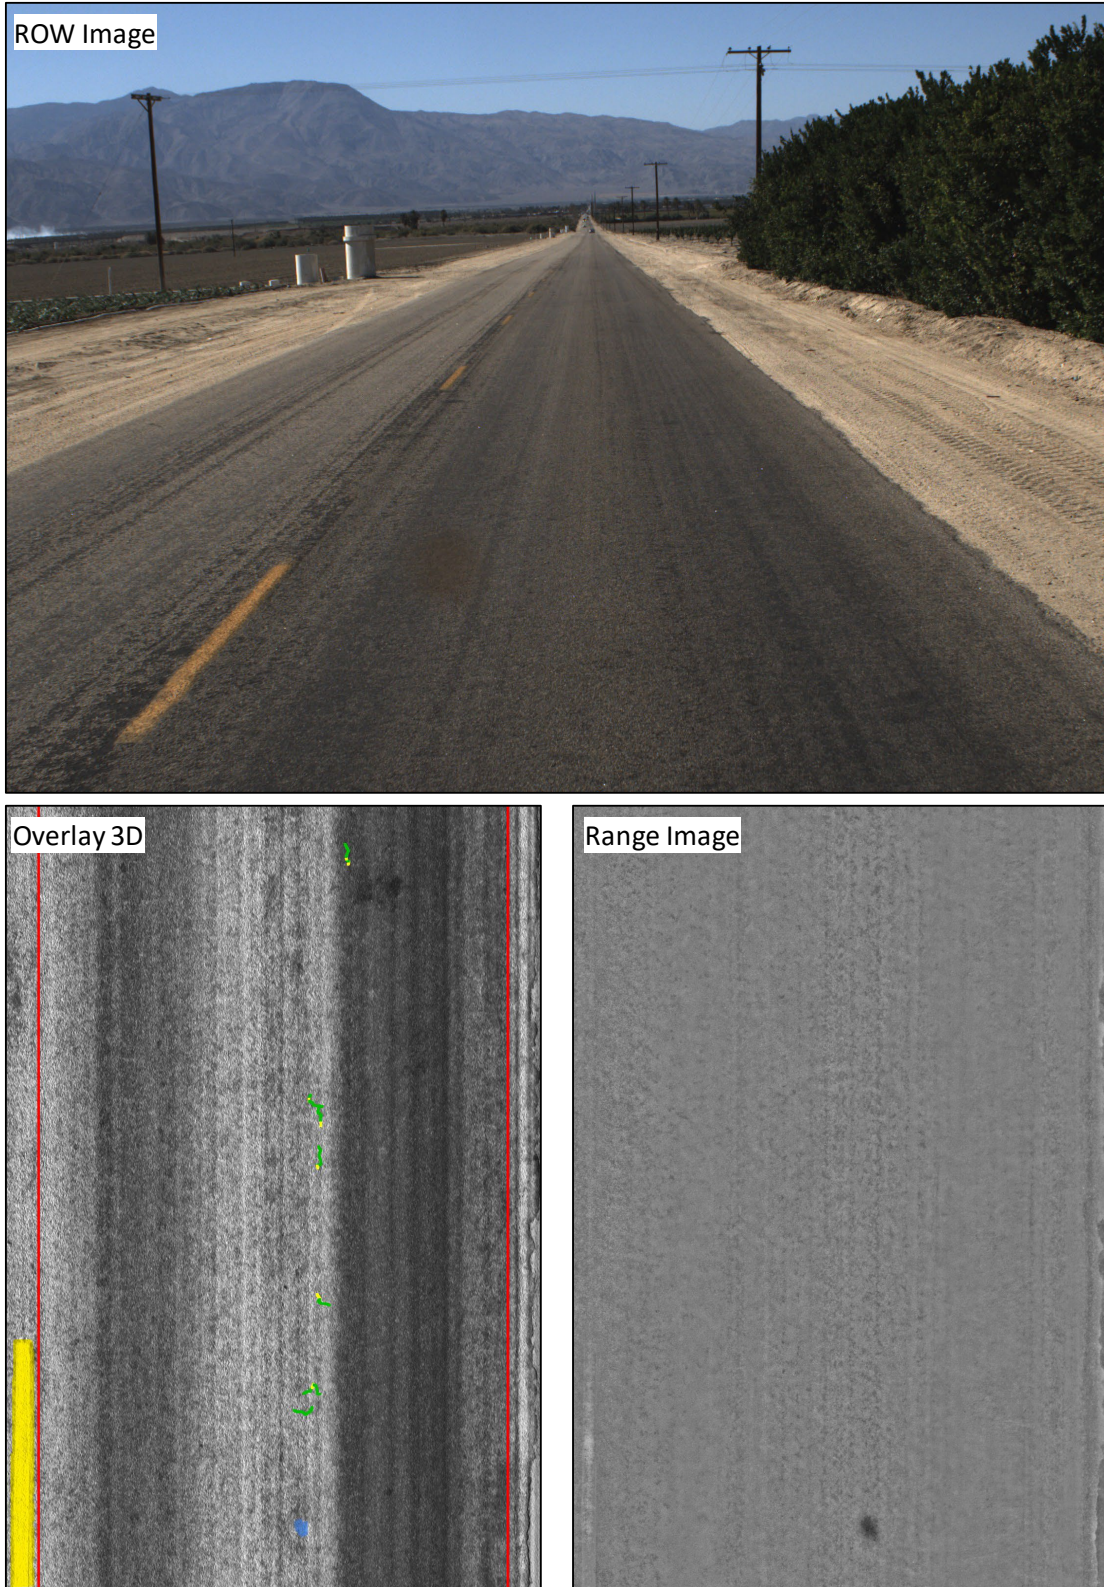
**Figure 10A. PCI=99 (Excellent Condition)**

Figures 10A to 10H show different pavement sections with decreasing PCI values. The images are the Right of Way (ROW) image, the 3D downward laser image with identified cracks highlighted, and the 3D range image that smooths surface texture to highlight crack details.
